Test Report

No. 20150907/01

Tests on electric and optical fibre cables under fire conditions -Part 1-2: Test for vertical flame propagation for a single insulated wire or cable - Procedure for 1 kW pre-mixed flame according to

AP Sensing S2002A/Steel colour: black, diameter: 3.8 mm

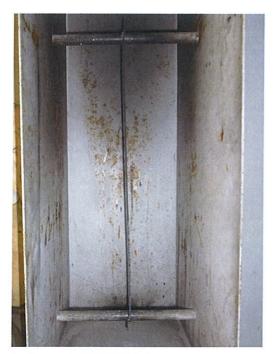
fig 1.: test rig IEC 60332-1-2

The test sample was attached in the test chamber according to IEC 60332-1-1:2004 and burned with a flame. The test sample was located in accordance with IEC 60332-1-2:2004. The applying of the flame corresponded to aforementioned standard. The temperature inside the test chamber was 25°C at the beginning of the test. The test rig stands in a testing hall so that external wind speed can be neglected. All other requirements of the above mentioned test standard was fulfilled. The test flame was applied for 60 seconds. The test was carried out at 03rd July 2015.

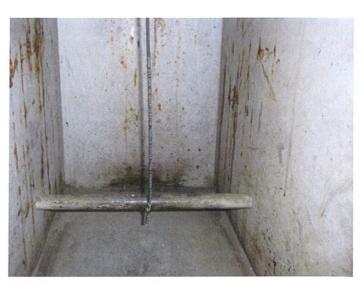
fig 2.: test rig probe in detail
